Outer Space Lessons for Earthside Safety

or IT ISN'T 'ROCKET SCIENCE'

James Oberg www.jamesoberg.com

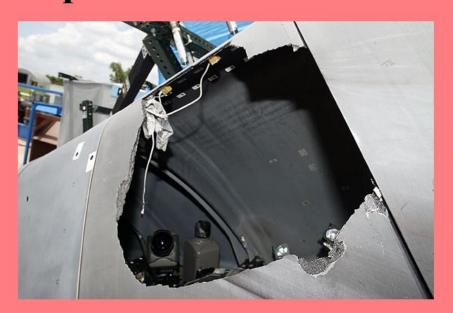
'RCC' Had Never Been Impact-Tested - photos of hole

Only safety concern for RCC was high-speed meteorite hit, not for 'slow' insulation impact

July 7, 2003 -test knocks head-sized hole in front edge.

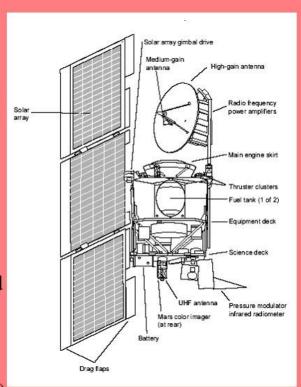
Official excuse: units mixup (English/metric)

Probe had one solar panel that resulted in gentle torque from 'solar wind', requiring small jet thrusters to fire every few days. Thrusters also pushed probe slightly off course. This was expected, but size of push was delivered in wrong units (so was about 5 times too small).
